OV-1 ACCIDENT SUMMARY

1 July 1963 through 30 June 1966

Investigation and Engineering Division
Engineering Branch

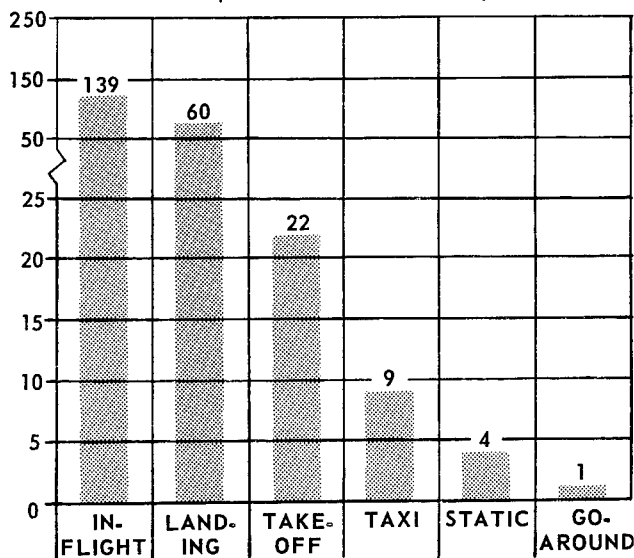
FIGURE 1
Phase of Operation in Which Mishap Started

VIII. PHASE OF OPERATION: Figure 1 shows the phases of operations in which mishaps started. The inflight phase accounted for 59% of all mishaps and the landing phase accounted for 25%. The majority of mishaps were caused by materiel failures or malfunctions.
